AAS 11-081

SOLAR DYNAMICS OBSERVATORY LAUNCH AND COMMISSIONING

NASA Goddard Space Flight Center

33rd ANNUAL AAS GUIDANCE AND CONTROL CONFERENCE

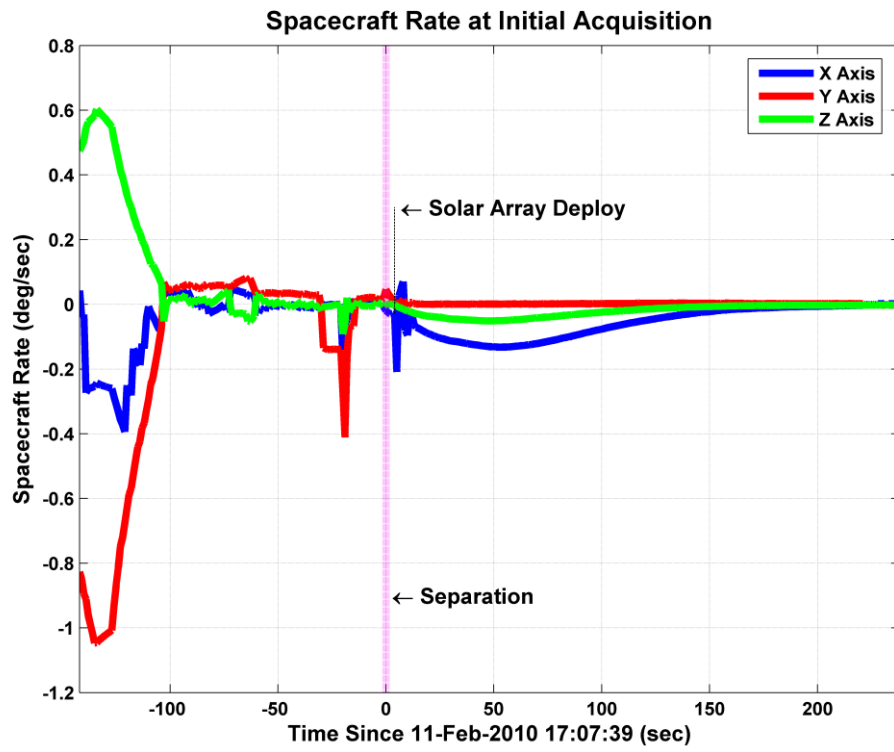
Figure 4: Separation and Acquisition Spacecraft Rates

After a one day launch slip caused by high winds at Cape Canaveral, SDO successfully launched at 15:23 GMT (10:23 EST) on February 11, 2010. On schedule an hour and thirty-six minutes later, the SDO Mission Operations Center established first contact with the spacecraft. At 17:07:39, SDO separated from the third stage of the Atlas V launch vehicle, having been safely delivered into its 8,800 km × 41,700 km, 28° geostationary transfer orbit. Figure 4 shows the SDO spacecraft rates leading up to and after spacecraft separation. (All times in plots are GMT.) The angular rates measured prior to separation are due to the third stage of the launch vehicle maneuvering SDO into its separation attitude. As shown, the separation event itself is relatively benign, imparting fairly low rates on the spacecraft, a total of 3 Nms of system momentum. SDO's solar arrays deployed automatically approximately five seconds after separation. Figure 5 shows the Sun angle, as measured by the CSSs, during initial acquisition. The requirement at initial acquisition for both SDO's SunAcq and Safehold Modes was to bring the spacecraft within 15° of the Sun within 30 minutes. In operation, SDO's SunAcq Mode was able to bring the spacecraft that close to the Sun within 15 seconds, with a total settling time of about three minutes. Note that, since the CSSs are located on the solar array panels, the Sun angles were not accurate until the solar arrays were deployed. Eighty-four minutes after separation, SDO's two HGAs were deployed. Figure 6 shows the spacecraft rate disturbance caused as each antenna was deployed; as expected, the primary disturbance is in the Y axis of the spacecraft.

After a lot of time and effort, the anomaly team proposed three simple, easy-to-implement changes to the spacecraft that they felt would solve the problem. First, they suggested increasing the length of the settling burn from 20 seconds to four minutes. That length was selected to encompass the “geyser mode” that can be seen upon initial thruster firing, but did not allow enough time for fuel disturbances to damp out before the main engine firing. Second, the team suggested raising the FDC limit on system momentum to 34 Nms. The 20 Nms limit was chosen based on a two-failure scenario (how much momentum could be placed into the spacecraft by a stuck-on thruster and have the spacecraft successfully recover with one failed wheel); 34 Nms reflected a more realistic failure case. Finally, the team wanted to disable the effect of the structural filter, included in DeltaV Mode to allow it to meet the design requirement for 12 dB modal suppression of all flexible modes, by appropriately setting its parameters to ones and zeros. The increased phase delay caused by the structural filter was affecting DeltaV Mode’s ability to react to the slosh dynamics, and the observed flexible modes and damping seen during the appendage deployments (refer back to Figure 4 and Figure 6) indicated that this could be done safely.

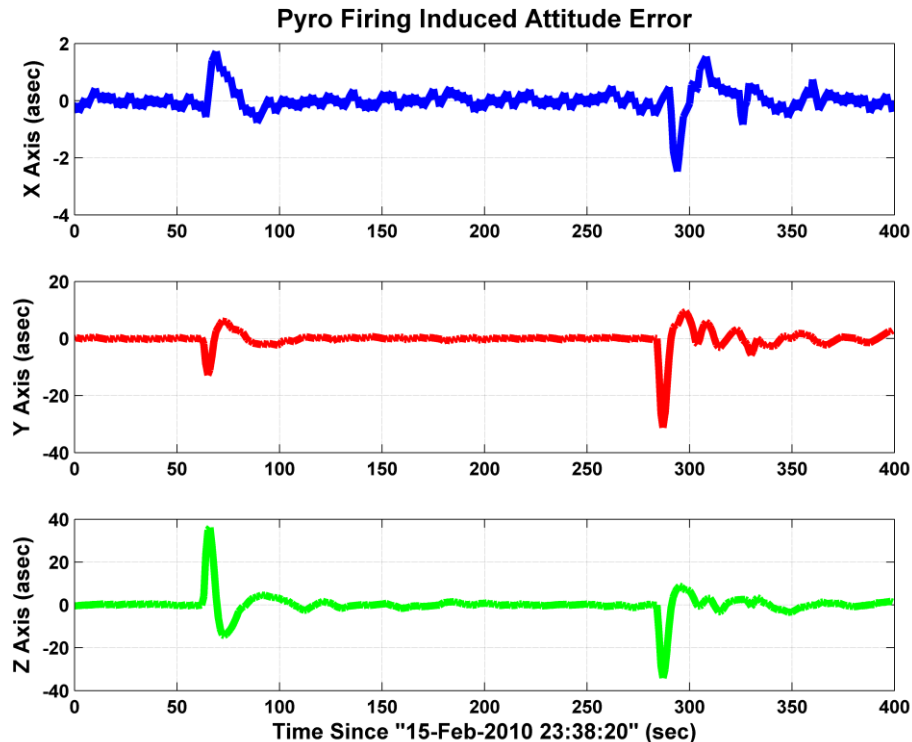
Figure 9: Attitude Error Induced by Firing Propulsion System Pyros

Due to heating concerns from one of the science instruments, the engineering burn was delayed from the nominal plan for four days, and was executed on February 15, at 02:42 GMT. Thruster polarity and rough thruster performance had been checked on launch day, so the only other propulsion system commissioning activity necessary before the engineering burn was to fire the pyrotechnic valves to pressurize the system. As shown in Figure 9, it was possible to see that the pyros had been fired based on disturbances to the spacecraft's attitude and rate.

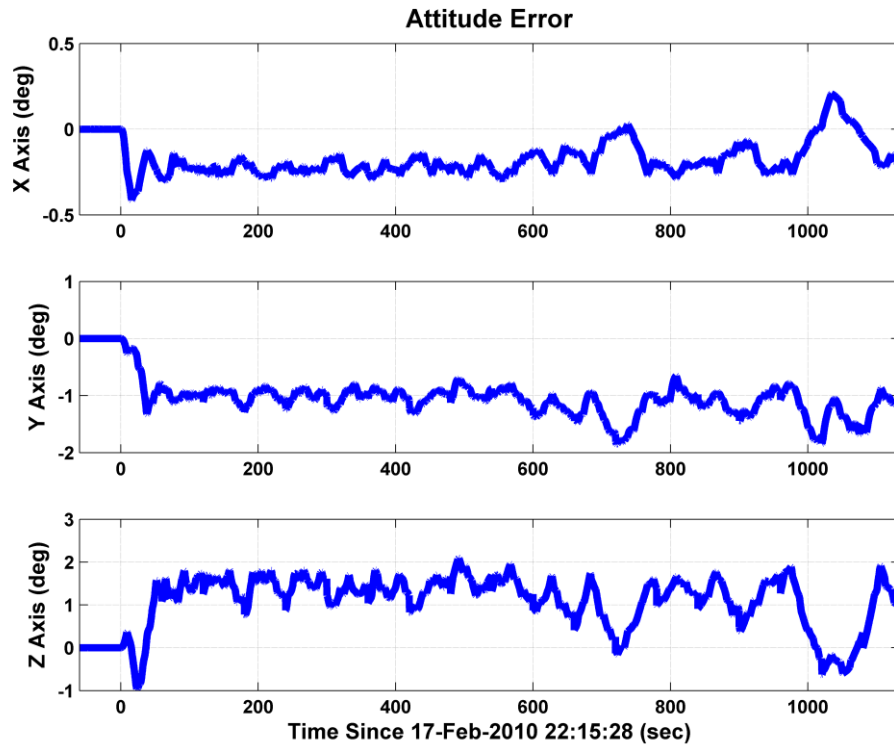
Figure 10: AMF-1 Attitude Error

Figure 10 shows the attitude error during AMF-1, beginning one minute before the burn started. As expected, because the main engine is aligned along the X axis, the primary disturbances are in the Y and Z axes. The attitude errors during the maneuver are kept to within $\pm 2^\circ$, for the most part, well within the $\pm 5^\circ$ requirement and FDC limit for DeltaV Mode. As also shown in Figure 10, the limit cycle during DeltaV Mode is one-sided for most of the burn. Towards the end of the burn, though, we see what looks like a two-sided limit cycle. Figure 11 shows the phase plane plot of the maneuver, as well as a plot of the system momentum magnitude. To give some sense of directionality on the phase plane plots, the data is plotted with the first third of the burn in red, the second third in green, and the last third in blue. As would be expected in the phase plane after seeing the attitude error, all of the limit cycles appear to be stable, with the Z axis being the largest. The system momentum magnitude plot is what would be hoped for in a well-behaved control mode. After an initial transient when the main engine kicks in after the settling burn (which is well within the FDC limit of 20 Nms), it varies for the rest of the maneuver at a fairly low level.

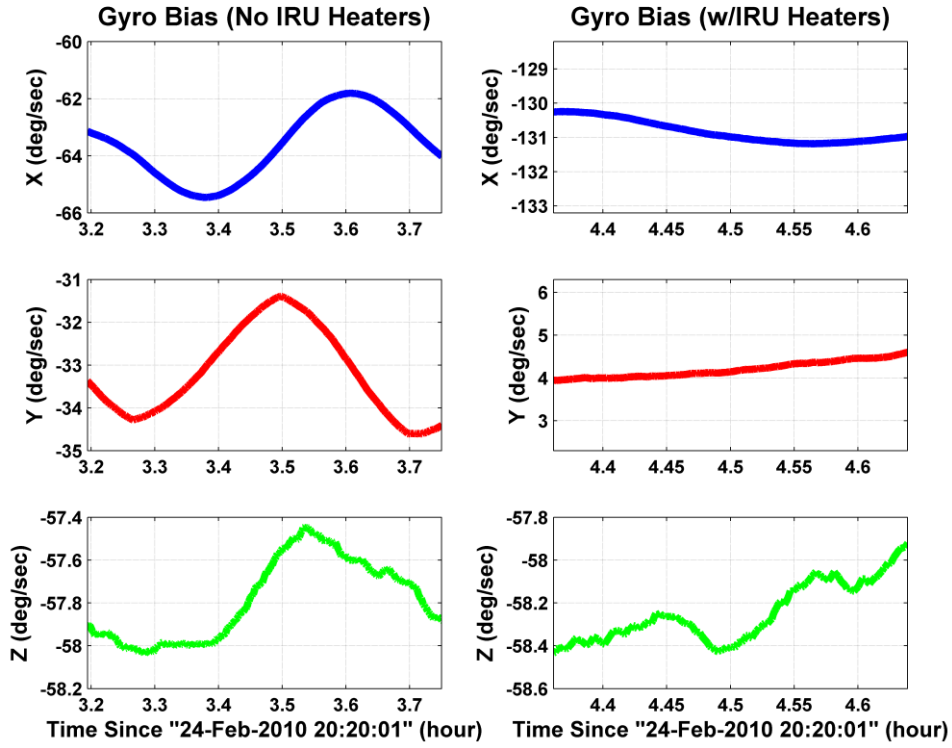
Figure 16: Gyro Biases with and without IRU Heaters

The day after launch, the major activities were the checkout of Inertial Mode, followed by a series of slews using that mode to provide data to calibrate the IRUs. Both of those activities were successful, but small spacecraft oscillations were observed in the IRU bias estimates calculated by the onboard Kalman filter, as shown in the plots on the left hand side of Figure 16. Because the oscillation was at such a low frequency, with a roughly 30 minute period, they were well within the bandwidth of the controller, so the controller followed the oscillating error in the attitude estimate, resulting in actual spacecraft motion. The fact that the spacecraft was actually tracking these oscillations is shown in the guide telescope error signals on the left-hand side of Figure 17. Data from these tests, from subsequent tests of SDO Science Mode, and from all other suitable activities were examined. The oscillations seen on all of the different tests were approximately 10–20 arcsec and would not cause SDO's Science Mode to violate its pointing requirement of [35,70,70] arcsec, but they remained a concern to the science instrument teams. It was determined by looking at this data that the IRUs were the cause, and that the frequency and the amplitude of the oscillations was temperature related.

Because of concerns of the effect of the 87 Hz frequency of the IRU's internal heaters on the spacecraft power bus, the decision had been made not to use them in flight except during a few crucial operations. As a result the IRUs experienced temperature variations that were different from the manufacturer's design and testing profile. That these temperature variations caused the bias oscillations was confirmed by first running a test with the IRU internal heaters turned on; the results of this are shown in the bias estimates and guide telescope signals in the plots on the right hand sides of Figure 16 and Figure 17. Note that because of different average temperatures, the secular component of both the gyro bias estimate and guide telescope error signals are different in the unheated and heated cases, but the scales of each side-by-side plot are the same to show the lower magnitude of the oscillatory component. This test established that the bias oscillation could be reduced through use of the IRU internal heaters, but concerns about the effects on the spacecraft power system remained.

After the first IRU internal heater test, the flight support team ran two tests instead using software-based control of the IRU heaters, first with a setpoint of 40 C and then with a setpoint of 67 C. The software control was relatively coarse, allowing peak-to-peak variations about the setpoint of roughly 2 C. As expected, changing the temperature setpoints resulted in changes to the amplitude and frequency of the observed oscillations. However, they did not significantly decrease the magnitude of the oscillations.

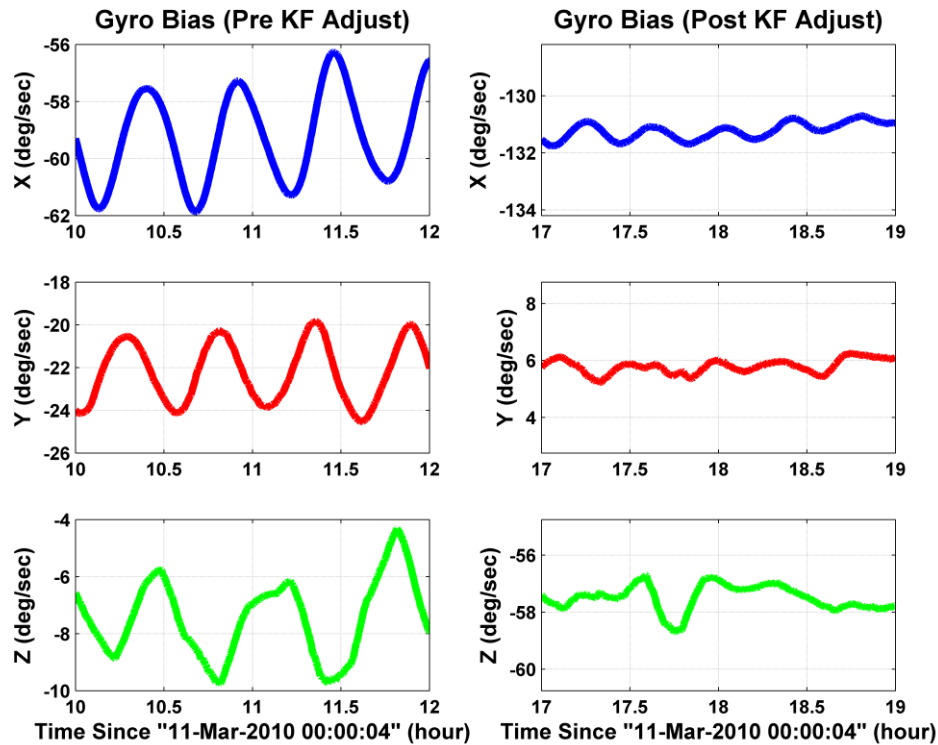
Figure 18: Gyro Biases before and after Adjusting Kalman Filter Gains

Figure 18 shows a plot of the estimated gyro biases before and after the adjustment of the Kalman filter gains. As can be seen, while the retuned filter does not eliminate the oscillations completely—certainly not as much as using the IRU internal heater—it does diminish their magnitude significantly, bringing the actual oscillation of the Observatory down to a level acceptable to the SDO science teams.
